AUSTRALIAN ASPHALT PAVEMENT ASSOCIATION

**Procure Recycled: Paving the Way
Phase 2 initiative (Rubber)**

Demonstration Projects Report Part 2

V1.1 May 2025

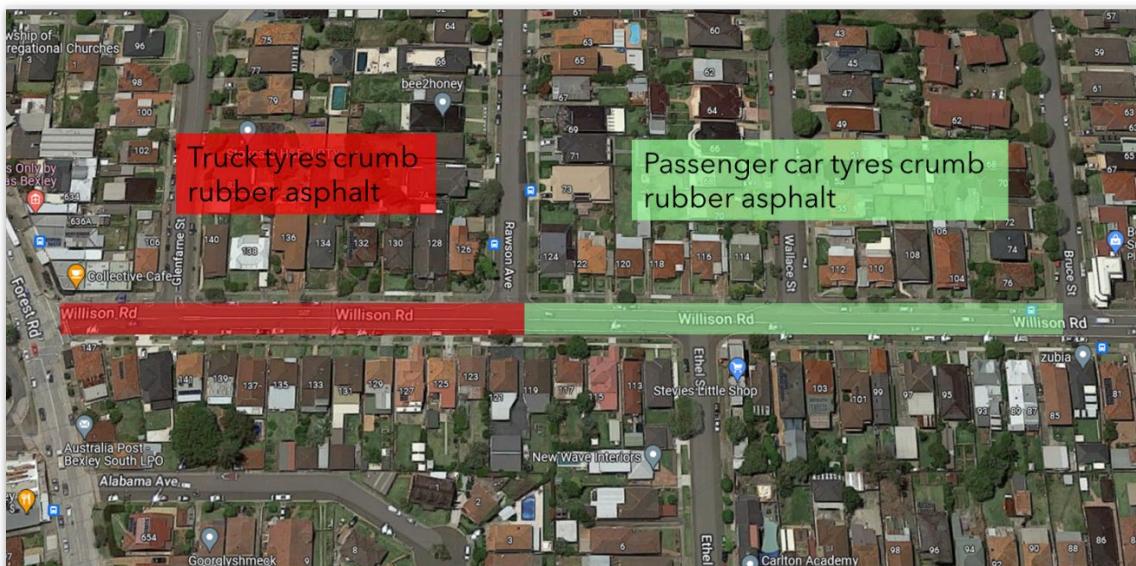
Figure 1 Project site at Bayside City Council. The green hatched area shows the location of the passenger car tyres CRM asphalt mix, whereas the red hatched area shows the truck tyres CRM asphalt mix.

Paving operations at Bayside City Council were conducted on Willison Rd. in May 2023 by Boral Asphalt NSW. Willison Rd. is located in the suburb of Bexley in Sydney, New South Wales (Figure 1). The road runs through a residential area. The project included the resurfacing of the section of Willison Rd. between Forest Rd. and Byrnes St. This section presented extensive longitudinal cracking along the wheel paths and joints, and previous patching interventions, mostly in the direction of traffic from Willison Rd. towards Railway St. Potholes were also scattered along Willison Rd. both in the traffic and parking lanes.

A deeper than usual asphalt mill and fill intervention (60 mm) was planned by the Council to address the pavement distresses. Two different asphalt mix designs were laid, both of them included CRM asphalt. However, the source of the CR was different with the first section using CR from truck tyres (TT) exclusively, whereas the second section only used CR from passenger car tyres (PT). Both sections were resurfaced using a gap graded CRM asphalt mix (wet method) with approximately 18% of rubber by weight of the binder.

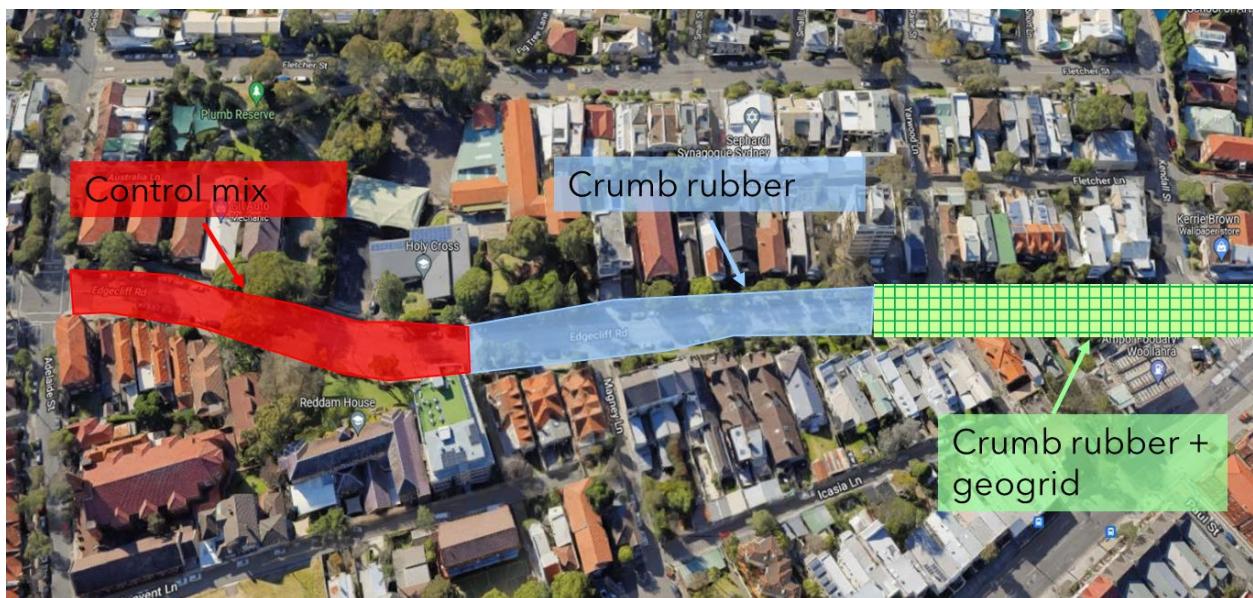
Figure 11 Project site at the City of Woollahra

The green and light blue hatched areas show the location of the crumb rubber modified asphalt, whereas the red hatched area shows the conventional asphalt mix design.

Paving operations at the City of Woollahra were conducted on Edgecliff Rd. in June 2023 by Boral Asphalt NSW. Edgecliff Rd is located in the inner eastern suburbs of Sydney in New South Wales (Figure 11). It runs North-South from New South Head Rd to Old South Head Rd in Woollahra. The section of Edgecliff Rd due for resurfacing extended from Adelaide St to Kendall St.

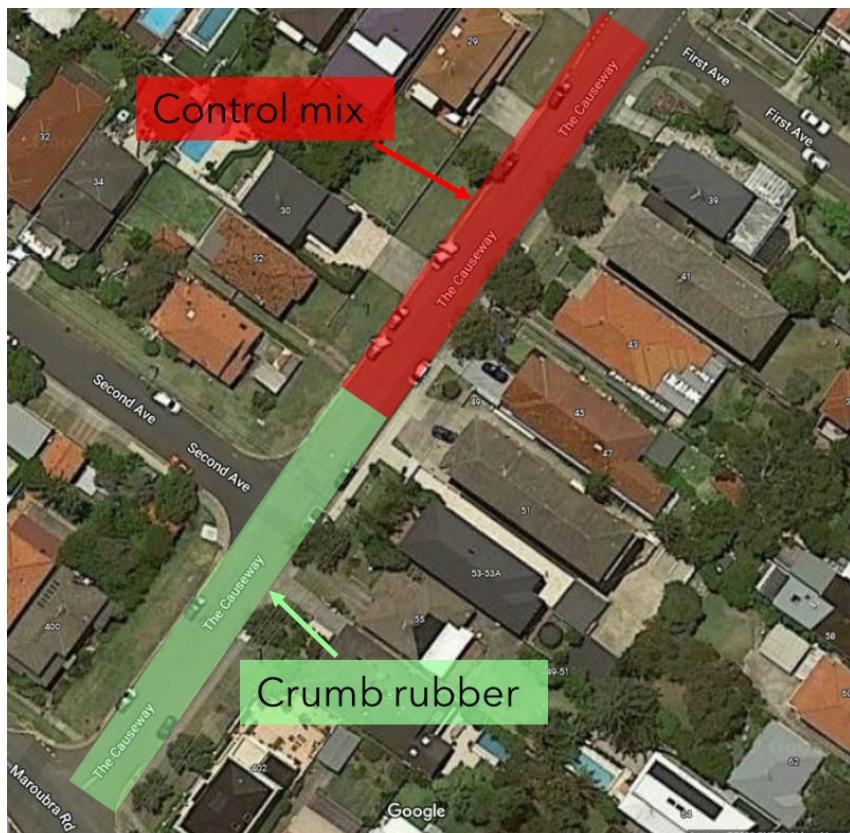
Figure 16 Project site at Randwick City Council. The green hatched area shows the location of the crumb rubber modified asphalt, whereas the red hatched area shows the conventional asphalt mix design.

An asphalt mill and fill intervention (40 mm) was planned by the Council to address those pavement distresses. Two different asphalt mix designs were laid: a conventional dense graded asphalt mix and a dense graded CRM asphalt mix (wet method) with approximately 15% of CR by weight of the binder.

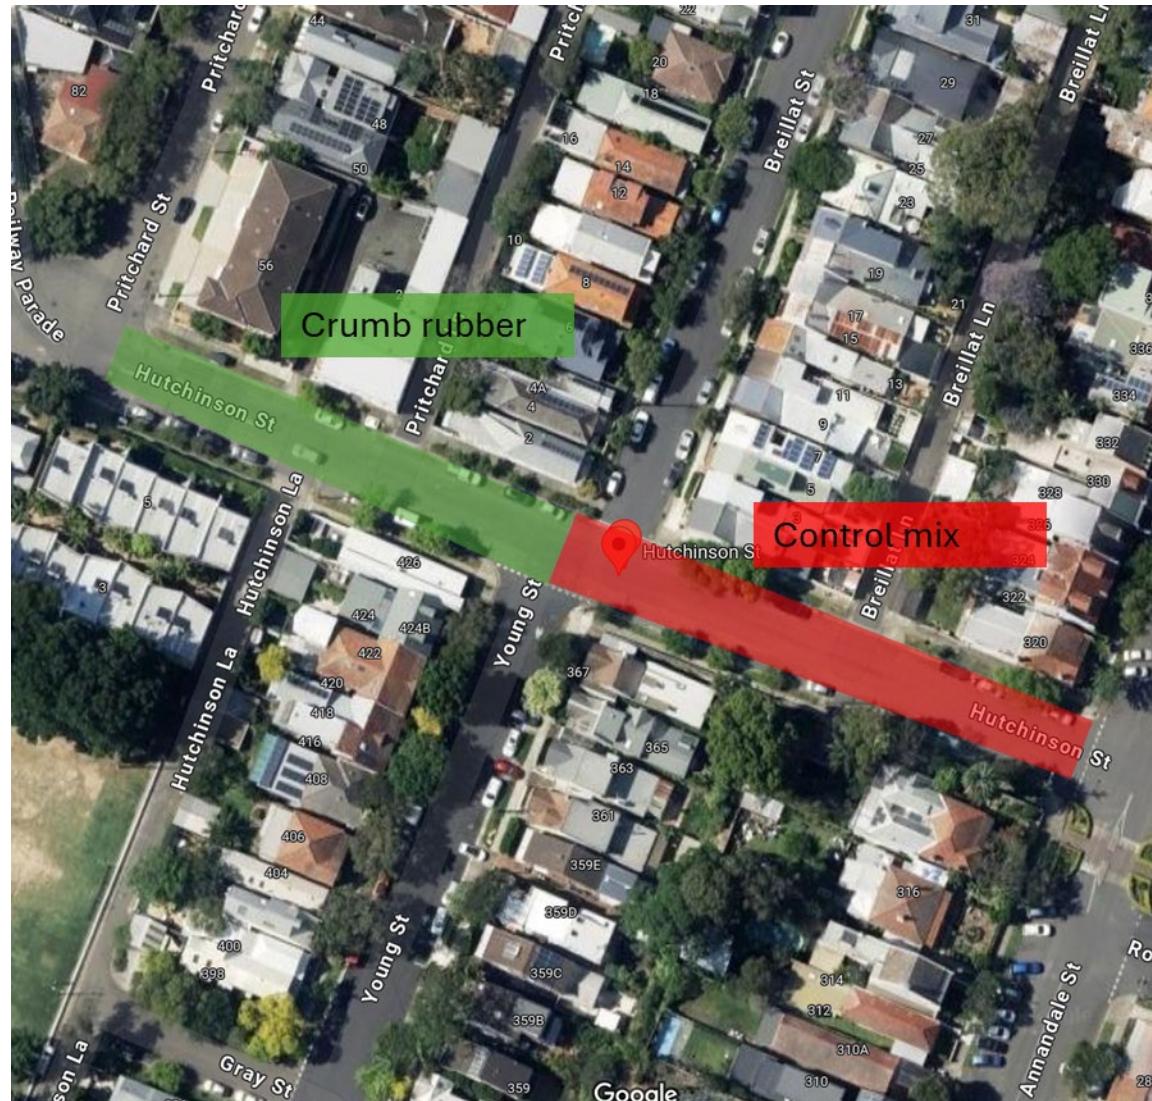
Figure 31 Project site at Inner West Council. The green hatched area shows the location of the crumb rubber modified asphalt, whereas the red hatched area shows the conventional asphalt mix design.

The Council planned a standard maintenance intervention that included asphalt milling and filling (40 mm) to address the pavement distresses. Two different asphalt wearing course mixes were laid: a conventional dense graded asphalt mix and a dense graded CRM asphalt mix (wet method) with approximately 9% of rubber by weight of the binder.

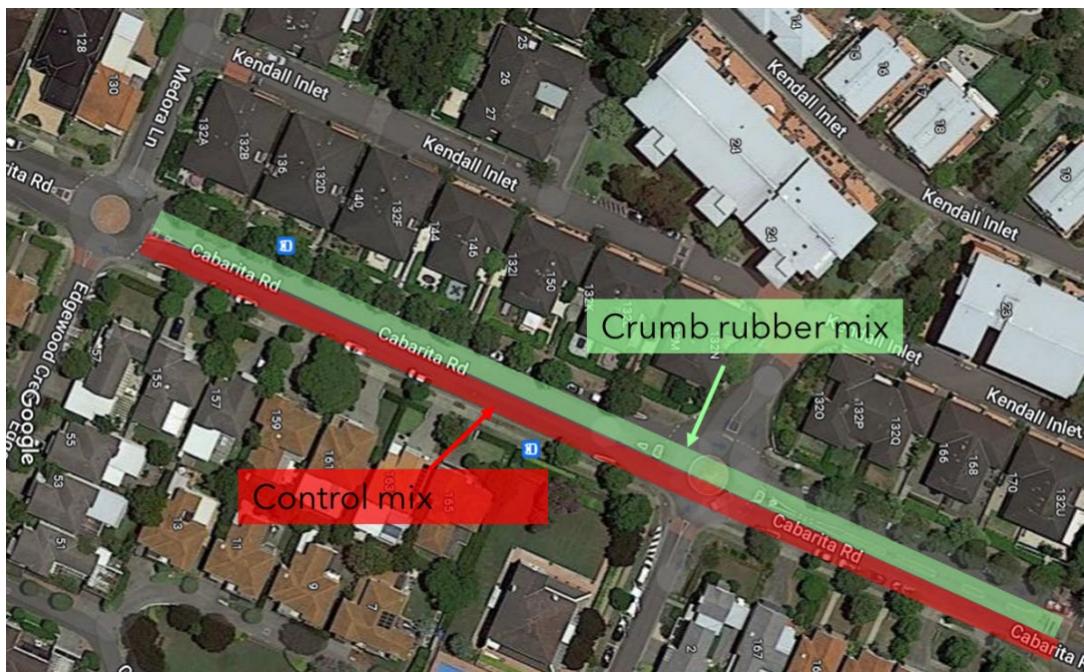
Figure 37 Project site at the City of Canada Bay. The green hatched area shows the location of the crumb rubber modified asphalt, whereas the red hatched area shows the conventional asphalt mix design.

The poor conditions of the road, mostly due to heavy bus traffic, showed crocodile cracking and rutting. Therefore, the Council planned for a thicker than usual (60 mm) mill and fill intervention. Two different asphalt mix designs were laid side-by-side (i.e. one on each traffic lane). This choice considers that the same volume of traffic enters and exits through the park access gate due to the site's specific layout. A conventional dense graded asphalt mix and a dense graded CRM asphalt mix (wet method) with approximately 15% of rubber by weight of the binder were used in this project.

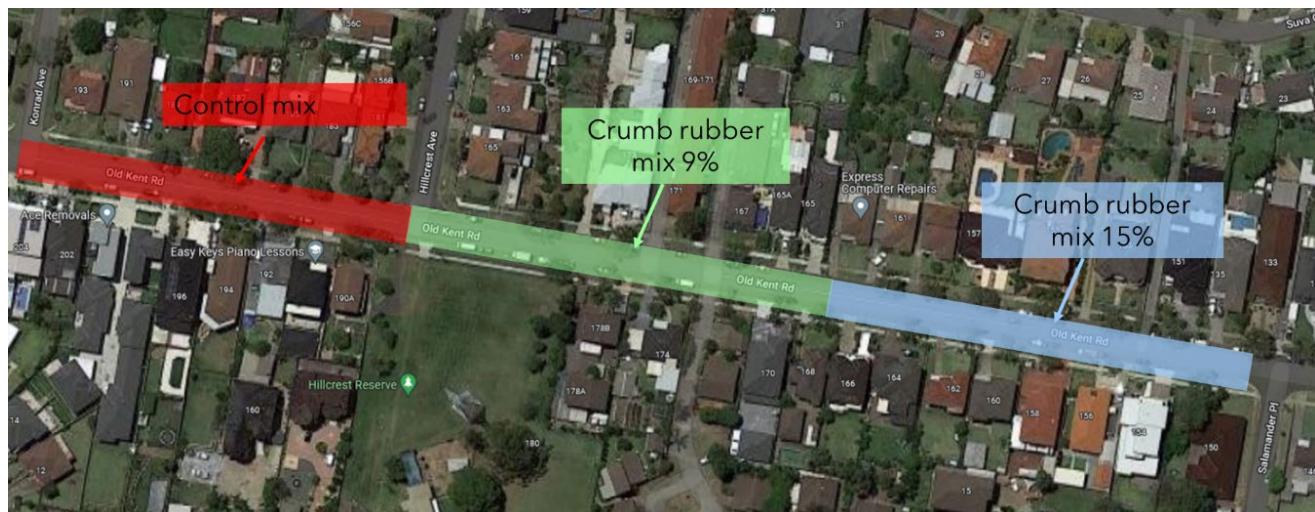
Figure 42 Project site at the City of Canterbury-Bankstown. The light blue and green hatched areas show the location of the crumb rubber modified asphalt, whereas the red hatched area shows the conventional asphalt mix design.

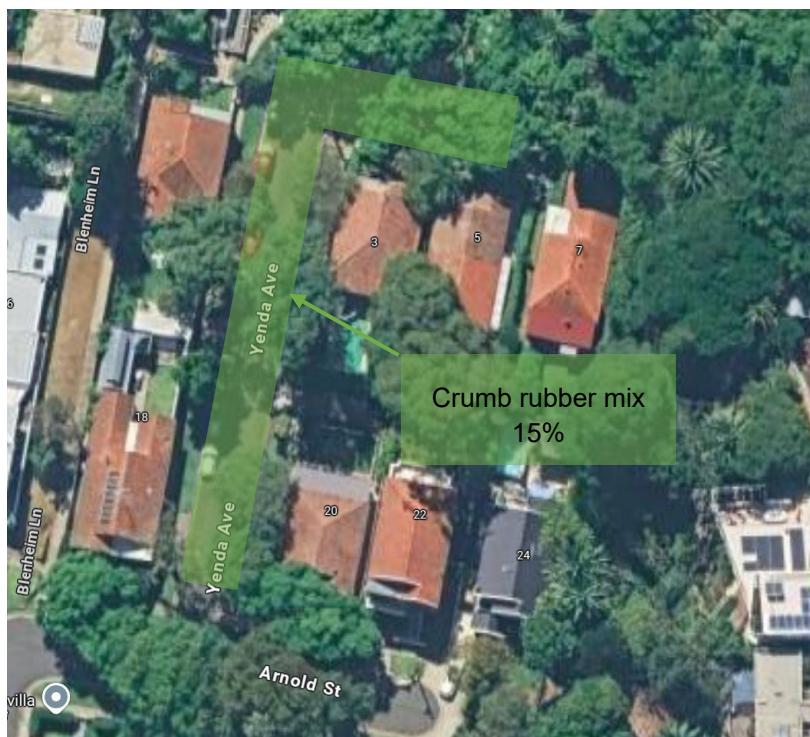
Figure 47 Project site at Waverley Council. The green hatched area shows the location of the crumb rubber modified asphalt. No control mix was laid at Waverley council due to the small size of the road project.

A dense-graded CRM) asphalt mix, produced via the wet method and containing approximately 15% rubber by weight of binder, was used for this project.
